**Flood Control Project Maintenance
Levee Inspections**

Fall 2018 Levee Maintenance Deficiency Summary Report

San Joaquin River Basin

Reclamation District No. 2089 Stark

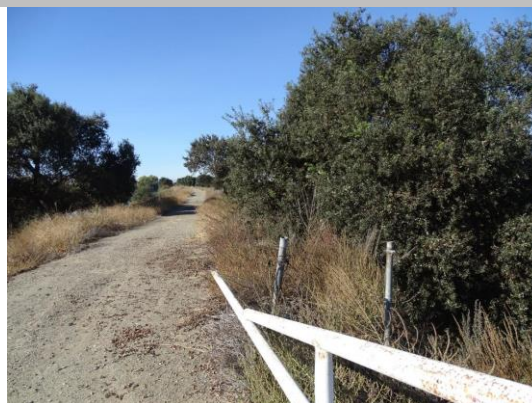
Photo 1 of 1 : FA_2018_RD2089_316_24_20181101_00053.jpg

Typical view of landward slope. (Fall 2018)

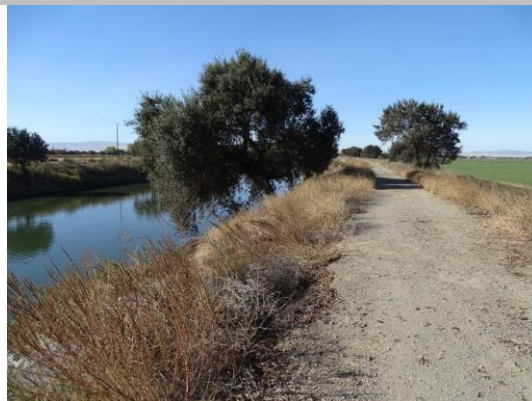
Photo 1 of 1 : FA_2018_RD2089_316_16_20181101_00054.jpg

LM Start	0.02	Rating **	U	Issue No.	16
LM End	1.51	Issue Type +	Ma	Location *	WS
Category	Earthen Levee			GPS Latitude/Longitude	
				Start	End
Item	Vegetation			37.811547 °	37.806633 °
				-121.385268 °	-121.407885 °
DWR ID	DWR_RD2089_01_f_2018_16				
Comment Code					
V1 : Control annual grass and weeds on the levee slopes and easements.					
Inspector Comment

Looking at typical view of waterward slope. (Fall 2018)

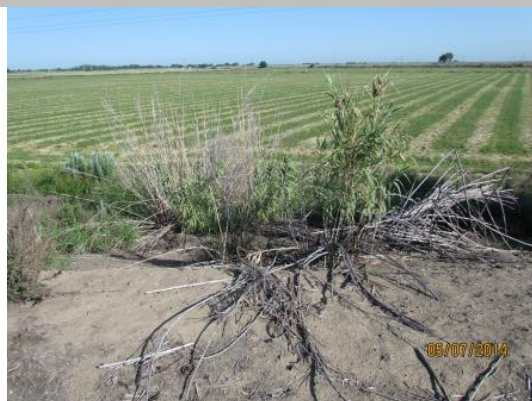
Photo 1 of 1 : FA_2018_RD2089_316_940_20180906_00037.jpg

The LMA is actively trying to remove the vegetation on the landside levee slope and toe.

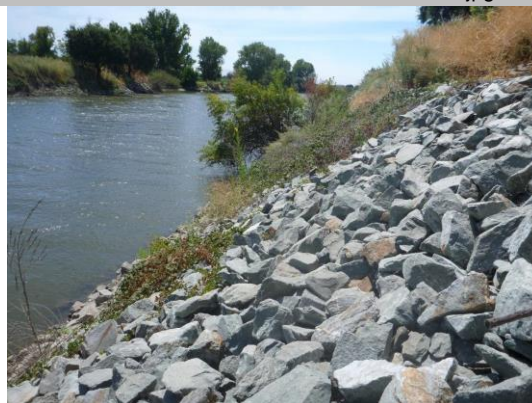
Photo 1 of 2 : LEVAL_FA_2018_513_4443.jpg

LM Start	0.26	Rating **	M	Issue No.	13
LM End	0.27	Issue Type +	Ma	Location *	
Category	Supplemental			GPS Latitude/Longitude	
				Start	End
Item	2017 Storm Damage			37.810300 °	37.810300 °
				-121.389300 °	-121.389500 °
DWR ID	DWR_RD2089_01_f_2017_13				
Comment Code					
Inspector Comment					
Levee Evaluation Comments					
Description:Slope protection repairs are needed along the waterside slope due to erosion and riprap displacement from high water. Based upon levee inspections, it was determined the waterside levee slope is eroding, deteriorating, and degrading. The eroded levee sections need to be restored back to design standards to prevent further deterioration and damage.					
Site ID No:513					
Site Designation:LMA-419					
Repair Type: Erosion					
Rating:Area of Concern					
Field Date:8/14/2017					
Notes: Small erosion at toe.

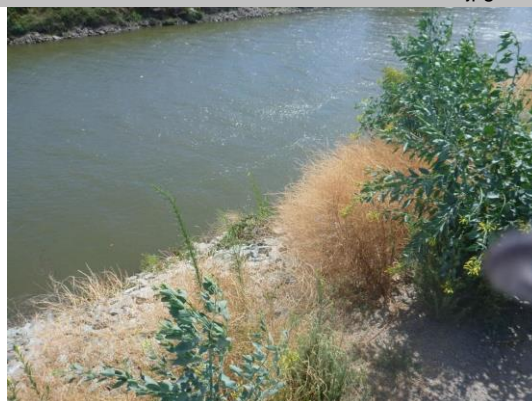
Photo 2 of 2 : LEVAL_FA_2018_513_4448.jpg

LM Start	0.26	Rating **	M	Issue No.	13 (cont)
LM End	0.27	Issue Type +	Ma	Location *	
Category	Supplemental			GPS Latitude/Longitude	
				Start	End
Item	2017 Storm Damage			37.810300 °	37.810300 °
				-121.389300 °	-121.389500 °
DWR ID	DWR_RD2089_01_f _ 2017_13				
Comment Code					
Inspector Comment					
Levee Evaluation Comments					
Description:Slope protection repairs are needed along the waterside slope due to erosion and riprap displacement from high water. Based upon levee inspections, it was determined the waterside levee slope is eroding, deteriorating, and degrading. The eroded levee sections need to be restored back to design standards to prevent further deterioration and damage.					
Site ID No:513					
Site Designation:LMA-419					
Repair Type: Erosion					
Rating:Area of Concern					
Field Date:8/14/2017					
Notes: Small erosion at toe.

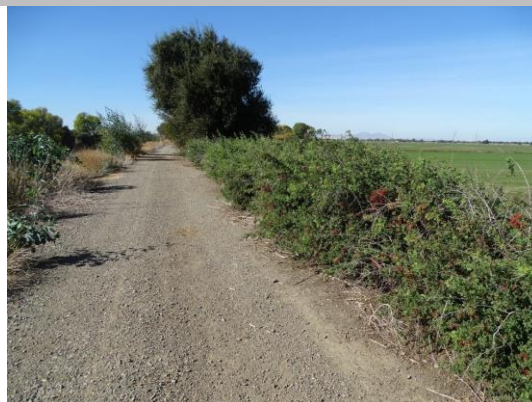
Photo 1 of 1 : FA_2018_RD2089_316_23_20181101_00057.jpg

LM Start	0.30	Rating **	U	Issue No.	23
LM End	0.32	Issue Type +	Ma	Location *	LS
Category	Earthen Levee			GPS Latitude/Longitude	
				Start	End
Item	Vegetation			37.810138 °	37.810043 °
				-121.390020 °	-121.390343 °
DWR ID	DWR_RD2089_01_f_2018_23				
Comment Code					
V2 : Remove the wild growth other than native grasses from the levee slopes.					
Inspector Comment					
Berryvines and wildrose on landward shoulder and slope blocking view.

Looking at dense berryvines and wildroses on landward shoulder and slope. (Fall 2018)

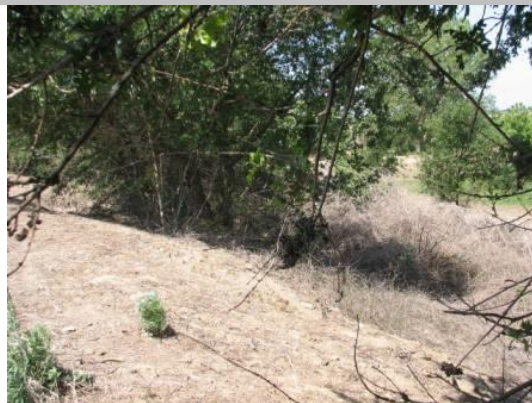
Photo 1 of 2 : FA_2018_RD2089_316_28_20180906_00025.jpg

05/24/2011 Photo shows thick dead vegetation and continuation of trees in area that are preventing access and visibility of landside slope and toe.

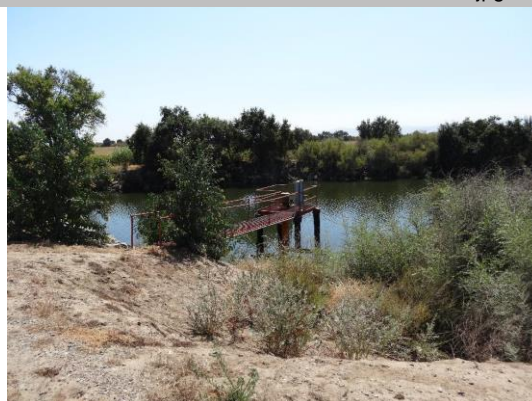
Photo 1 of 3 : UCIP_FA_2018_21635_36742.jpg

Comment Code						
Inspector Comment						
FS_ID:21635 DS_ID:23042 EP_NO: 5641 Repair Type: Non-Urgent Crossing Status: Found UCIP Comments: - damaged siphon breaker.- most of the pipe on landside exposed on levee slope. FIELD_STRUCT_DESC: 20-inch steel irrigation discharge pipe and electrical conduit through the levee, 5.8 feet below the crown. Pump on a pile structure in the stream. Siphon breaker on the landside (LS) slope. (Plans to replace a rusted out irrigation discharge pipe through the levee authorized under Permit No. 5641, 1967 - Theodore Stark). [Additional Reference(s): DWR Levee Log, 1991. USACE San Joaquin O&M Manual 8, 1968, (HLM 0.46), 21-inch pipe referenced]. FS Date: 9/12/2013

WS view: walkway to pump platform and pump on steel piling structure in the channel.

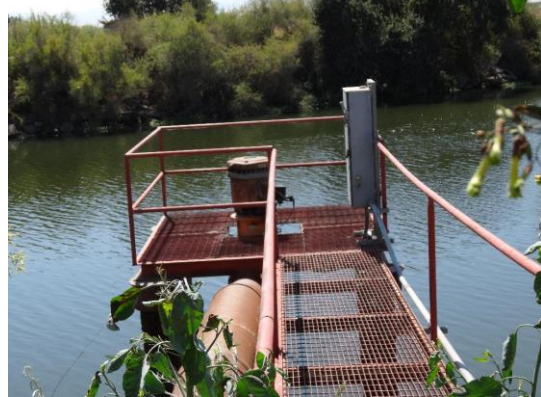
Photo 2 of 3 : UCIP_FA_2018_21635_36741.jpg

Comment Code						
Inspector Comment						
FS_ID:21635 DS_ID:23042 EP_NO: 5641 Repair Type: Non-Urgent Crossing Status: Found UCIP Comments: - damaged siphon breaker.- most of the pipe on landside exposed on levee slope. FIELD_STRUCT_DESC: 20-inch steel irrigation discharge pipe and electrical conduit through the levee, 5.8 feet below the crown. Pump on a pile structure in the stream. Siphon breaker on the landside (LS) slope. (Plans to replace a rusted out irrigation discharge pipe through the levee authorized under Permit No. 5641, 1967 - Theodore Stark). [Additional Reference(s): DWR Levee Log, 1991. USACE San Joaquin O&M Manual 8, 1968, (HLM 0.46), 21-inch pipe referenced]. FS Date: 9/12/2013

WS view: steel walkway, electric control box, and pump on steel piling structure in the channel.

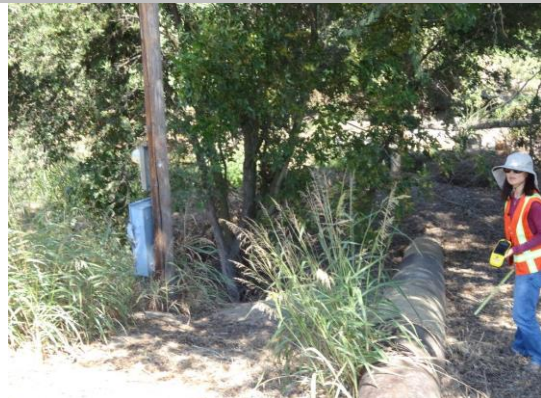
Photo 3 of 3 : UCIP_FA_2018_21635_36740.jpg

LS view: overview of exposed steel pipe (right) on levee slope and service pole (left).

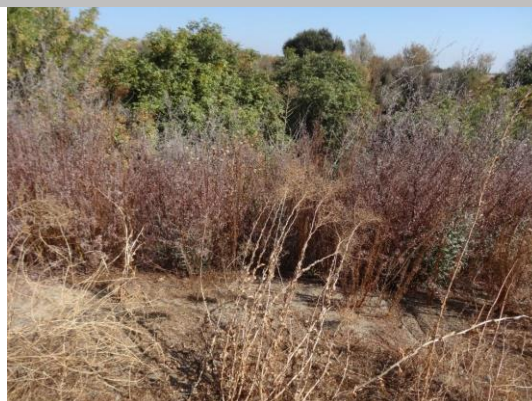
Photo 1 of 2 : FA_2018_RD2089_316_5_20180906_00007.jpg

Comment Code					
Inspector Comment					
09/13/2017: No significant change observed.					
07/25/2016: No significant change observed.					
06/25/2015: No significant change observed.					
07/02/2014: No significant change observed.					
08/13/2013: No significant change observed.					
08/07/2012: The site has been visited by boat survey. No significant change observed					
08/23/2011: The 5-foot vertical scarp shows no significant change from the last year inspection. No new erosion activities observed. Dense white willow trees on site.					
09/07/2010: It was difficult to view the erosion due to the thick Willow thickets and other vegetation at the water line. At the time of the inspection, there were no signs of repair on site. As noted during the last survey, there is a 5-foot vertical scarp along the lower slope that may be subjected to high flow velocities.					
08/05/2010: Recommended for repair, per CLRO; "Erosion of this site may be subjective to rapid rates of erosion."

09/28/2009: No major change observed; 5-foot vertical scarp is immediately downstream of where berm has tapered; site is recommended as local maintenance issue, per CLRO CES Evaluation 2008 Report; Site # is the same as RM29.6, LM0.60; previously rated "U".					
11/05/2008: No change observed; rodent holes on lower slope; wide levee crown. [2017 Site ID:RD2089U01RM29.61]

Front view of the site. The scarp erosion is at the levee slope but is not visible due to the dense vegetation at the site.

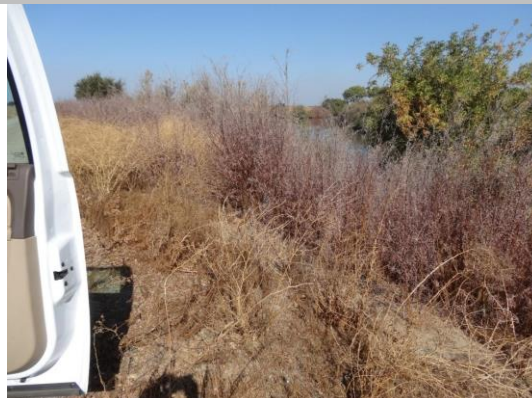
Photo 2 of 2 : FA_2018_RD2089_316_5_20180906_00008.jpg

Item	DWR Erosion Survey			37.809780 °	37.809780 °	
				-121.396230 °	-121.396230 °	
DWR ID	RD2089U01RM29.61					
Comment Code						
Inspector Comment						
09/13/2017: No significant change observed.						
07/25/2016: No significant change observed.						
06/25/2015: No significant change observed.						
07/02/2014: No significant change observed.						
08/13/2013: No significant change observed.						
08/07/2012: The site has been visited by boat survey. No significant change observed						
08/23/2011: The 5-foot vertical scarp shows no significant change from the last year inspection. No new erosion activities observed. Dense white willow trees on site.						
09/07/2010: It was difficult to view the erosion due to the thick Willow thickets and other vegetation at the water line. At the time of the inspection, there were no signs of repair on site. As noted during the last survey, there is a 5-foot vertical scarp along the lower slope that may be subjected to high flow velocities.

08/05/2010: Recommended for repair, per CLRO; "Erosion of this site may be subjective to rapid rates of erosion."						
09/28/2009: No major change observed; 5-foot vertical scarp is immediately downstream of where berm has tapered; site is recommended as local maintenance issue, per CLRO CES Evaluation 2008 Report; Site # is the same as RM29.6, LM0.60; previously rated "U".						
11/05/2008: No change observed; rodent holes on lower slope; wide levee crown. [2017 Site ID:RD2089U01RM29.61]

Front view of the site. Note the very dense white willow thickets on site.

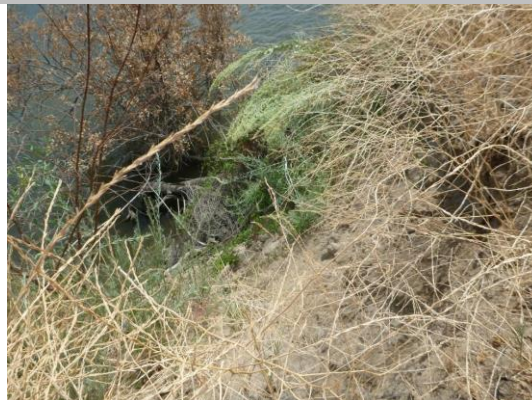
Photo 3 of 3 : LEVAL_FA_2018_512_4464.jpg

LM Start	0.67	Rating **	A/W	Issue No.	20 (cont)
LM End	0.68	Issue Type +	Ma	Location *	
Category	Supplemental			GPS Latitude/Longitude	
				Start	End
Item	2017 Storm Damage			37.809700 °	37.809700 °
				-121.396300 °	-121.396400 °
DWR ID	DWR_RD2089_01_f _ 2017_20				
Comment Code					
Inspector Comment					
Levee Evaluation Comments					
Description:Slope protection repairs are needed along the waterside slope due to erosion and riprap displacement from high water. Based upon levee inspections, it was determined the waterside levee slope is eroding, deteriorating, and degrading. The eroded levee sections need to be restored back to design standards to prevent further deterioration and damage.					
Site ID No:512					
Site Designation:LMA-418					
Repair Type: Erosion					
Rating:Serious					
Field Date:8/14/2017					
Notes: deep erosion more than half way up slope.

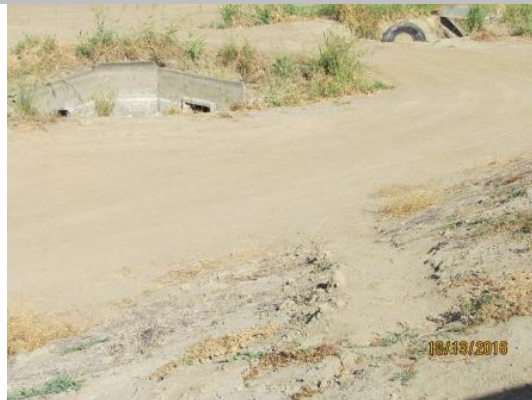
Photo 1 of 1 : FA_2018_RD2089_316_22_20180906_00022.jpg

LM Start	0.80	Rating **	M	Issue No.	22
LM End	0.80	Issue Type +	Ma	Location *	LS
Category	Earthen Levee			GPS Latitude/Longitude	
				Start	End
Item	Slope Stability			37.808466 °	37.808466 °
				-121.397847 °	-121.397847 °
DWR ID	DWR_RD2089_01_f_2016_22				
Comment Code					
S2 : Repair the levee slope damaged by foot traffic and prevent access where possible.					
Inspector Comment

View of the footpath on the landside levee slope.

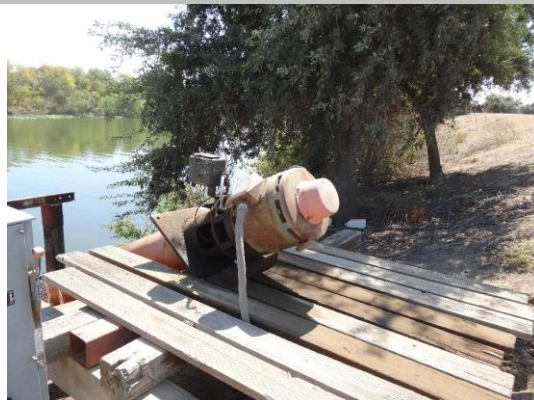
Photo 1 of 3 : UCIP_FA_2018_21587_36635.jpg

Comment Code						
Inspector Comment						
FS_ID:21587 DS_ID:23043 EP_NO: 3385 Repair Type: Non-Urgent Crossing Status: Found UCIP Comments: - powerline on landside.- electric control box on waterside.- waterside slope erosion under pump platform. FIELD_STRUCT_DESC: 16-inch irrigation discharge pipe of an unknown material through the levee, 5.5 feet below the crown. Two cutoff walls. Slant pump in a pump house on the waterside (WS) slope. Siphon breaker on the landside (LS) slope. (Plans for installation of a pumping plant on the riverbank and a pipe that crosses the levee authorized under Permit No. 3385, 1960 - Eleanor M. Lawrence). [Additional Reference(s): DWR Levee Log, 1991. USACE San Joaquin O&M Manual 8, 1968, (HLM 0.81)]. FS Date: 9/12/2013

WS view: slant pump on wooden platform. Oil leaks from the pump.

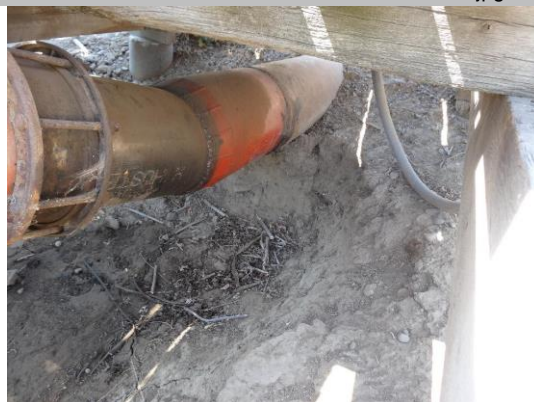
Photo 2 of 3 : UCIP_FA_2018_21587_36634.jpg

WS view: soil erosion under pump platform. Needs mitigation measures to stop erosion.

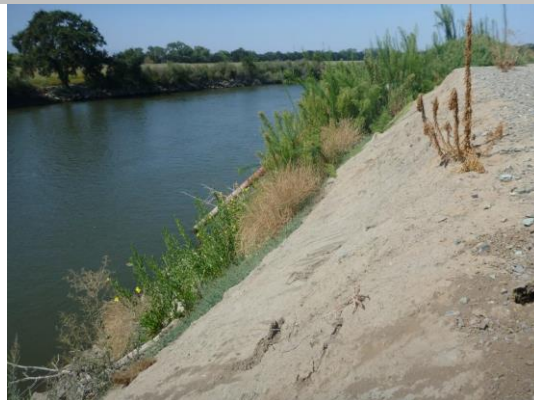
Photo 1 of 3 : LEVAL_FA_2018_511_4301.jpg

Description: Slope protection repairs are needed along the waterside slope due to erosion and riprap displacement from high water. Based upon levee inspections, it was determined the waterside levee slope is eroding, deteriorating, and degrading. The eroded levee sections need to be restored back to design standards to prevent further deterioration and damage.

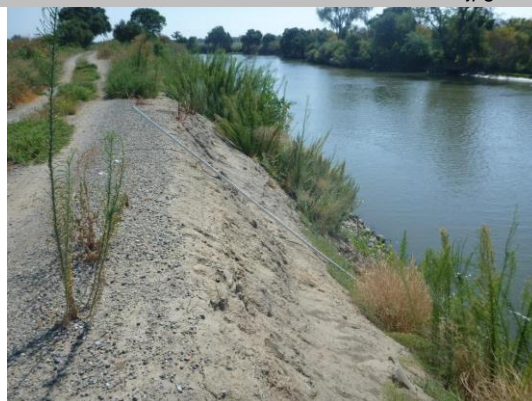
Photo 3 of 3 : LEVAL_FA_2018_511_4305.jpg

LM Start	1.16	Rating **	A/W	Issue No.	30 (cont)
LM End	1.18	Issue Type +	Ma	Location *	WS
Category	Supplemental			GPS Latitude/Longitude	
				Start	End
Item	2017 Storm Damage			37.805600 °	37.805600 °
				-121.401700 °	-121.401900 °
DWR ID	DWR_RD2089_01_f _ 2017_30				
Comment Code					
Inspector Comment					
Levee Evaluation Comments					
Description:Slope protection repairs are needed along the waterside slope due to erosion and riprap displacement from high water. Based upon levee inspections, it was determined the waterside levee slope is eroding, deteriorating, and degrading. The eroded levee sections need to be restored back to design standards to prevent further deterioration and damage.					
Site ID No:511					
Site Designation:LMA-417					
Repair Type: Erosion					
Rating:Critical					
Field Date:8/16/2017					
Notes: Narrow levee with over steep slope

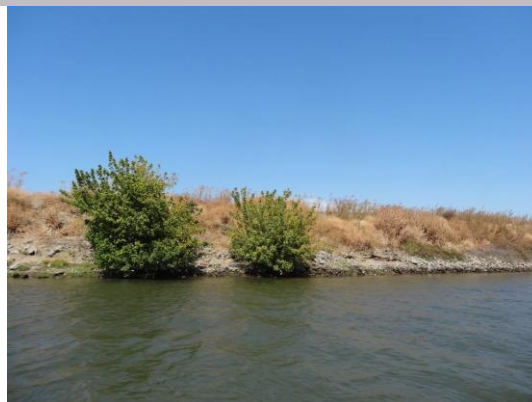
Photo 1 of 3 : FA_2018_RD2089_316_3_20180906_00004.jpg

LM Start	1.17	Rating **	A/W	Issue No.	3
LM End	1.17	Issue Type +	Ma	Location *	WS
Category	Supplemental			GPS Latitude/Longitude	
				Start	End
Item	DWR Erosion Survey			37.805523 °	37.805523 °
				-121.401718 °	-121.401718 °
DWR ID	RD2089U01RM29.1				
Comment Code					
Inspector Comment					
09/13/2017: The erosion is at the upstream of a small tree, inside of a slight river bend. [2017 Site ID:RD2089U01RM29.1]

Front view of the erosion. Note the trees next to the erosion site.

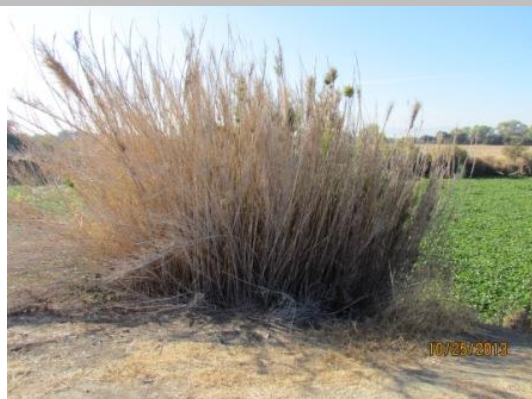
Photo 1 of 1 : FA_2018_RD2089_316_25_20180906_00023.jpg

View of the Arrundo on the waterside slope obstructing visibility. LMA is actively trying to remove the wild growth.

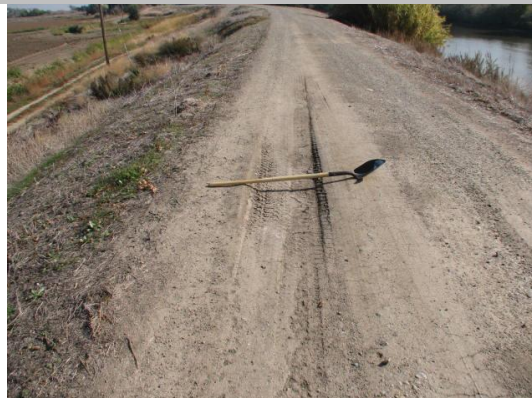
Photo 1 of 1 : FA_2018_RD2089_316_43_20180906_00032.jpg

11/10/2011 Depression in roadway.

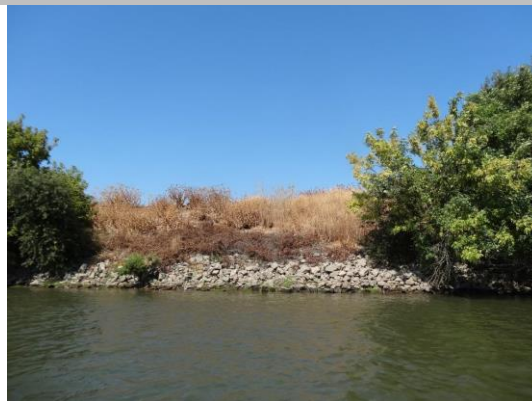
Photo 1 of 2 : FA_2018_RD2089_316_2_20180906_00002.jpg

LM Start	1.23	Rating **	M	Issue No.	2
LM End	1.24	Issue Type +	Ma	Location *	WS
Category	Supplemental			GPS Latitude/Longitude	
				Start	End
Item	DWR Erosion Survey			37.805580 °	37.805580 °
				-121.403010 °	-121.403010 °
DWR ID	RD2089U01RM29.04				
Comment Code					
Inspector Comment					
09/13/2017: No significant change observed. More vegetation observed at the site.					
09/16/2016: The river was not navigable near the site due to the dense water grass, so the site was visited by land survey. No significant change observed.					
06/25/2015: No significant change observed.					
07/02/2014: No significant change observed.					
08/13/2013: The erosion is around a tree at the levee toe. Dense vegetation is visible. [2017 Site ID:RD2089U01RM29.04]

Front view of the erosion.

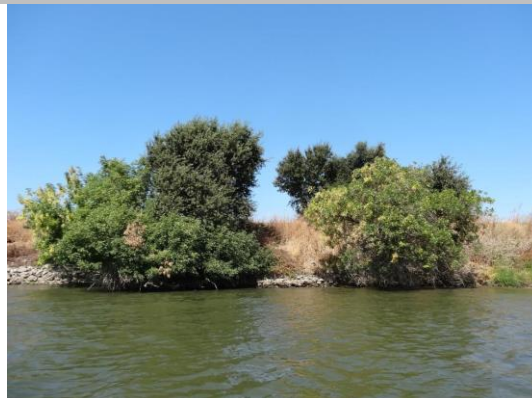
Photo 2 of 2 : FA_2018_RD2089_316_2_20180906_00003.jpg

Close view of the erosion.

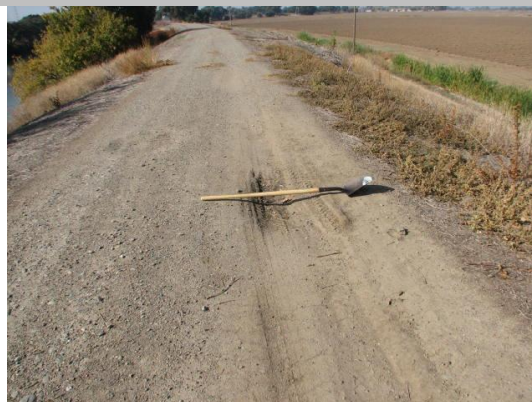
Photo 1 of 1 : FA_2018_RD2089_316_44_20180906_00033.jpg

11/10/2011 Roadway depression.

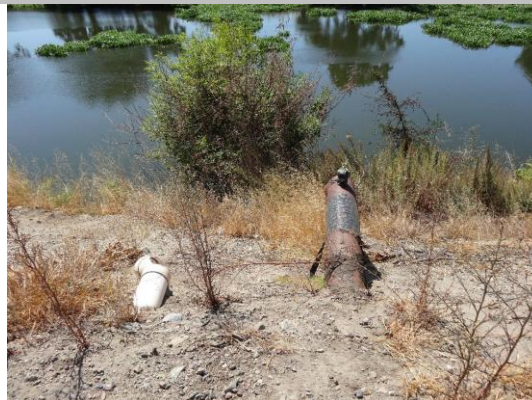
Photo 1 of 3 : UCIP_FA_2018_53379_36611.jpg

WS view: 6-inch pvc pipe on levee slope. Pipe end open and damaged.

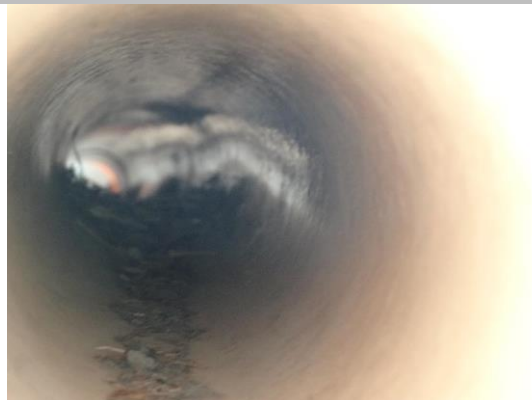
Photo 2 of 3 : UCIP_FA_2018_53379_36610.jpg

WS view: inside view of pvc pipe. Sediments found inside the pipe.

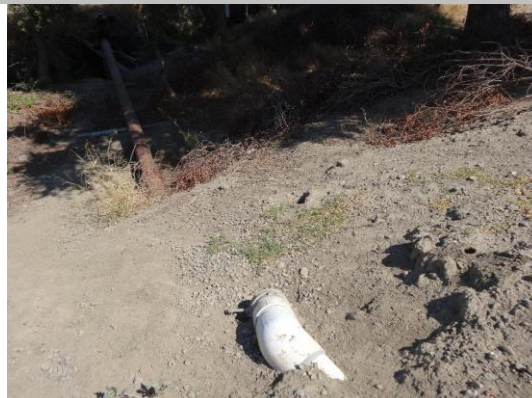
Photo 3 of 3 : UCIP_FA_2018_53379_36609.jpg

LS view: 6-inch pvc pipe on levee slope. Pipe end open.

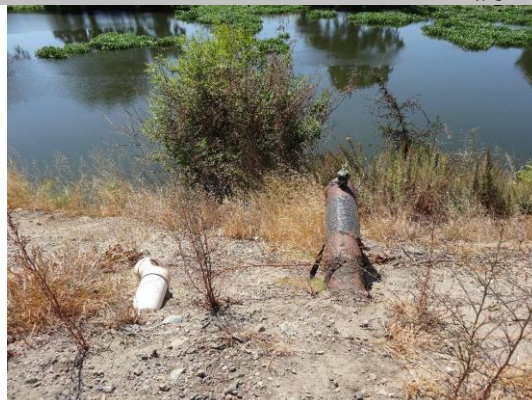
Photo 1 of 3 : UCIP_FA_2018_21585_36624.jpg

WS view: exposed steel pipe on levee slope. A pvc pipe on left.

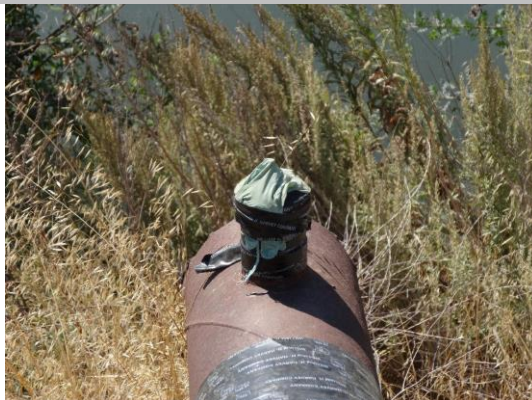
Photo 2 of 3 : UCIP_FA_2018_21585_36623.jpg

WS view: exposed steel pipe with siphon breaker. Looks siphon breaker needs repair.

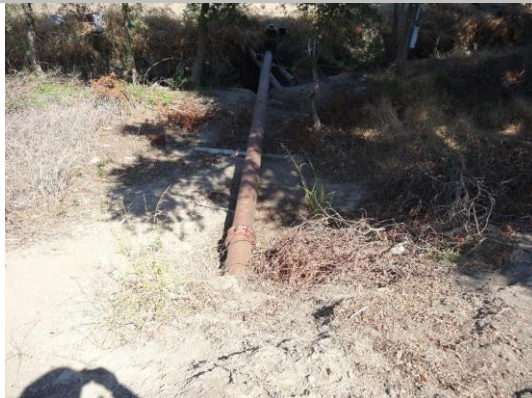
Photo 3 of 3 : UCIP_FA_2018_21585_36622.jpg

LS view: exposed steel pipe on levee slope.

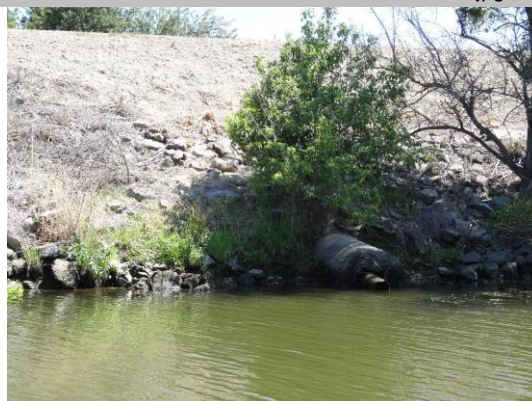
Photo 1 of 3 : UCIP_FA_2018_53182_74506.jpg

View up WS slope from water. Pipe does not cross channel.

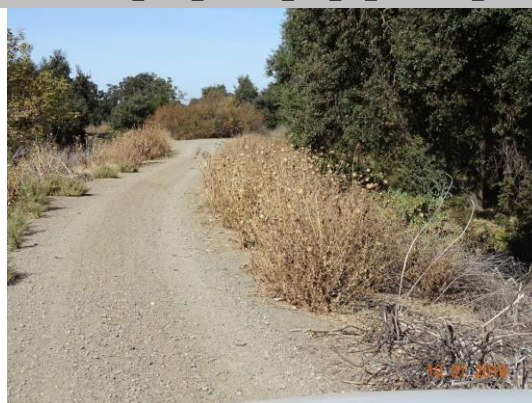
Photo 2 of 2 : FA_2018_RD2089_317_20_20181101_00064.jpg

View of dense veg on landward slope. (Fall 2018)

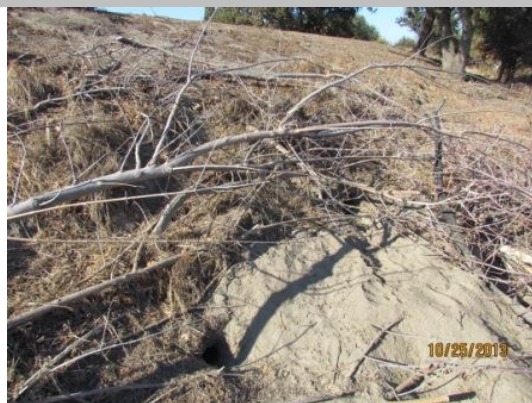
Photo 1 of 1 : FA_2018_RD2089_317_51_20180906_00049.jpg

View of the rodent burrow on the landside levee toe.

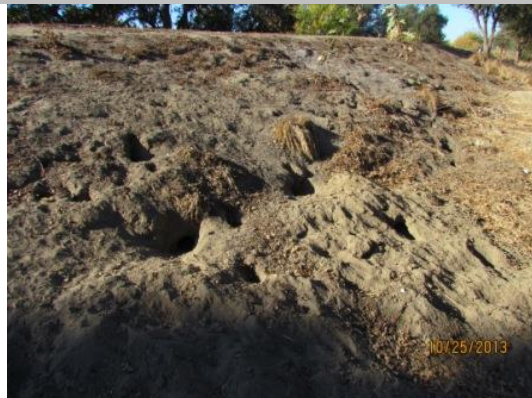
Photo 3 of 3 : FA_2018_RD2089_317_53_20180906_00053.jpg

Another view of the multiple rodent burrows on the landside levee slope.

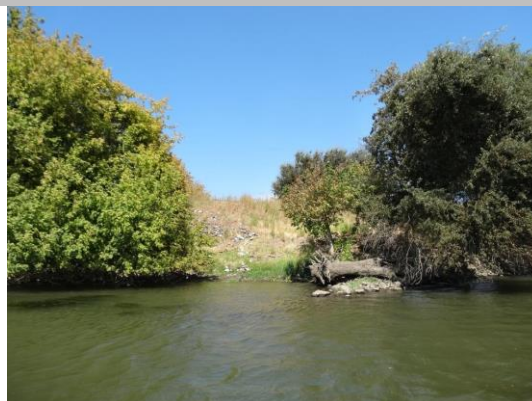
Photo 2 of 3 : FA_2018_RD2089_317_1_20180906_00002.jpg

Close view of the erosion.

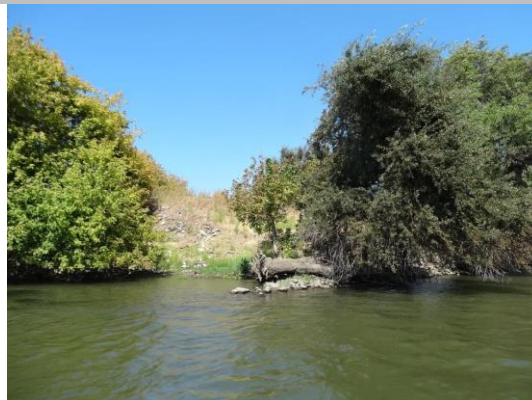
Photo 3 of 3 : FA_2018_RD2089_317_1_20180906_00003.jpg

Close view of the erosion.

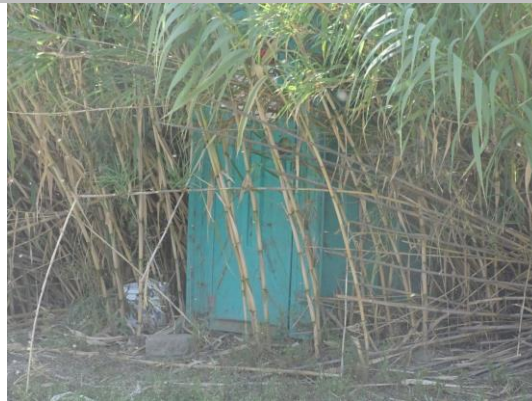
Photo 2 of 3 : FA_2018_RD2089_317_27_20181101_00066.jpg

Close-up view of portable toilet at water's edge. (Fall 2018)

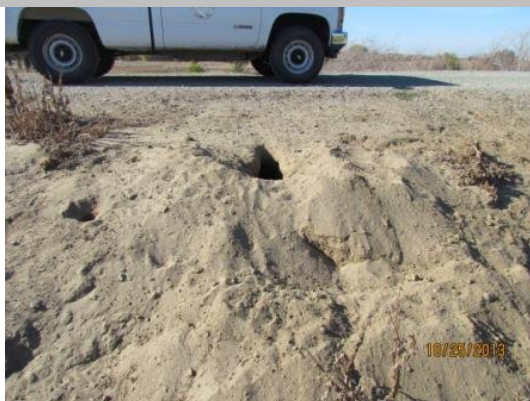
Photo 1 of 1 : FA_2018_RD2089_317_54_20180906_00054.jpg

View of the rodent burrow on the landside levee slope.

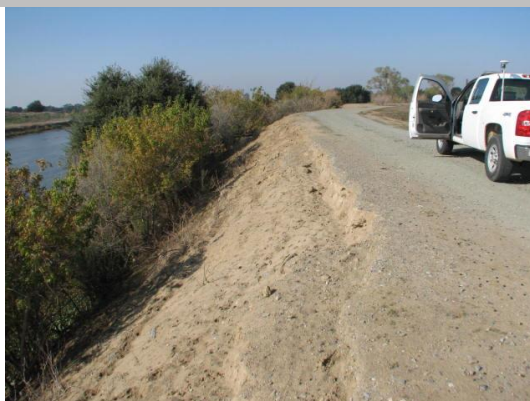
Photo 1 of 1 : FA_2018_RD2089_317_14_20180906_00015.jpg

11/10/2011 Approximately 1' scarp has been created by livestock travel.

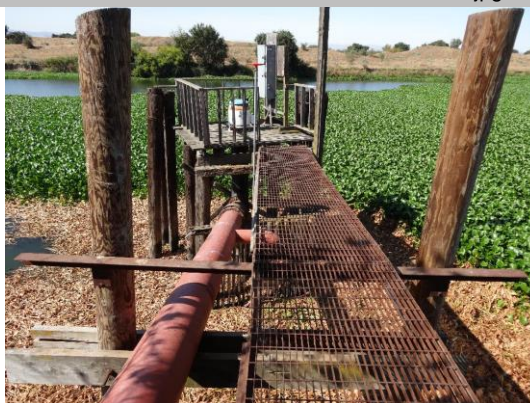
Photo 3 of 3 : UCIP_FA_2018_21676_36859.jpg

WS view: pipe (left) and steel walkway to pump on piling structure in the channel.

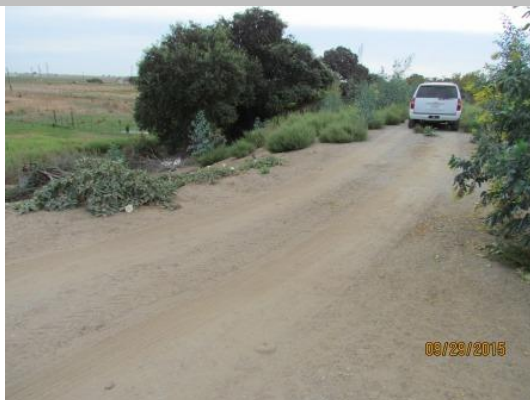
Photo 1 of 4 : FA_2018_RD2089_317_35_20180906_00028.jpg

View of the levee crown depression looking upstream.

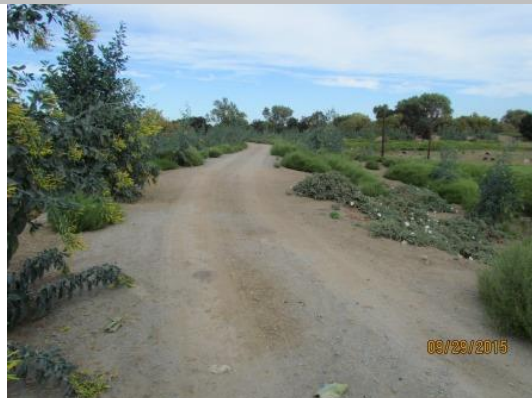
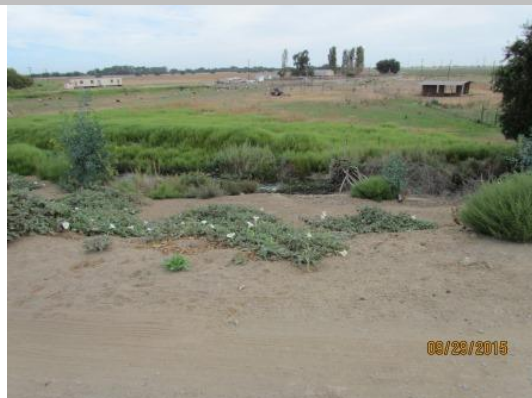
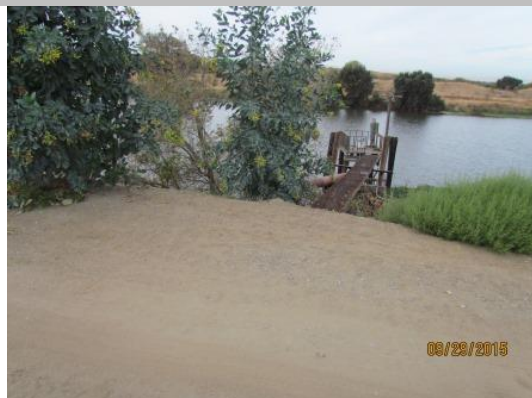
View of the levee crown depression looking to the waterside.

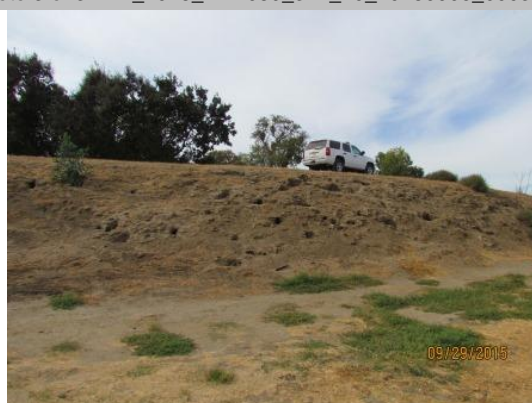
Photo 3 of 3 : FA_2018_RD2089_317_40_20180906_00035.jpg

View of the multiple rodent holes on the landside levee slope.

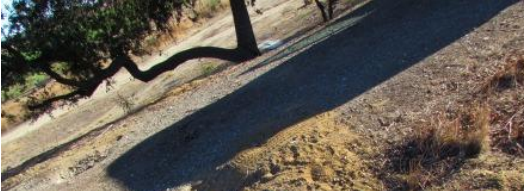
Photo 1 of 2 : FA_2018_RD2089_317_12_20180906_00012.jpg

View of several large rodent holes on the levee crown.

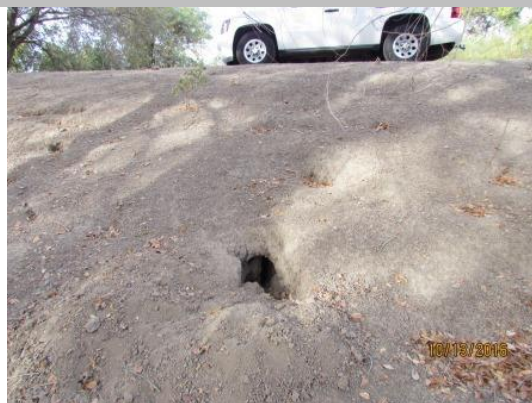
Photo 1 of 1 : FA_2018_RD2089_317_19_20180906_00020.jpg

View of the rodent burrow in the landside levee slope.

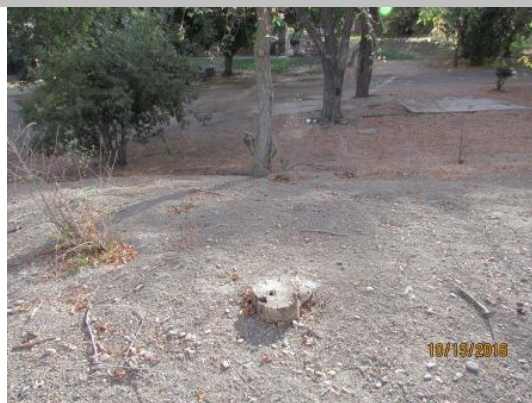
Photo 1 of 1 : FA_2018_RD2089_317_18_20180906_00019.jpg

View of the tree stump from the levee crown.

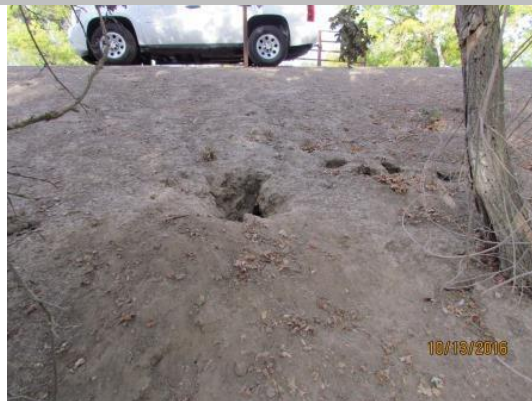
Photo 1 of 1 : FA_2018_RD2089_317_16_20180906_00017.jpg

View of the rodent burrow in the landside levee slope.
